THE 1921 SAULS HOUSE: ITS STORY AND RESTORATION

*1330 East Washington Street
Monticello, Florida*

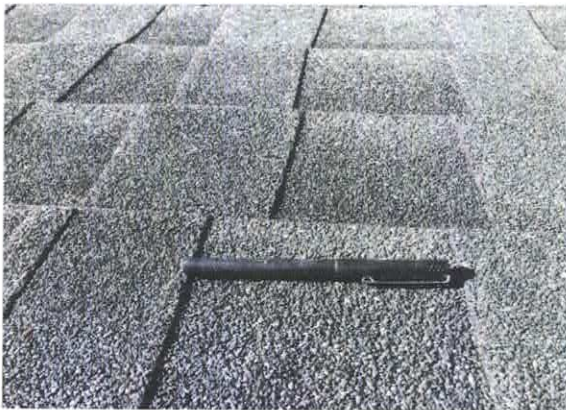
ROOF: The roof consists of a top-of-the-line heavy duty asphalt architectural shingle. When new, it had a 25-35 year life cycle rating. The

thick shingle is believed to have been installed in 2007 and is still in good condition. Ronnie Barrett, an experienced licensed roofer who performed routine maintenance on the roof, estimated its remaining useful life at 10-12 years.

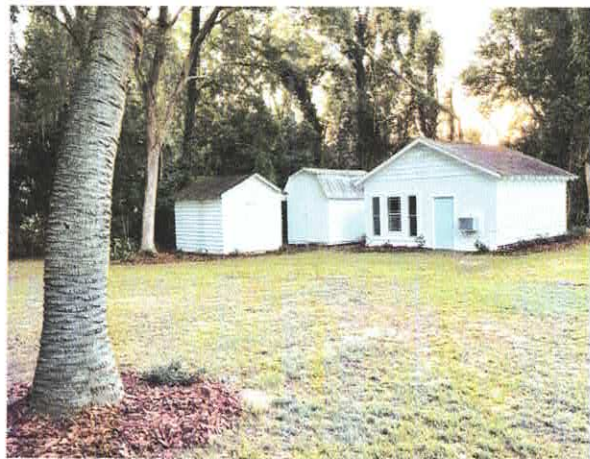
OUTBUILDINGS: An old garage has been converted to a spacious air-conditioned workshop/project room. Electrical was added to the old smoke-

house for lights and outlets. A more recently installed storage shed also has electrical for lights and is set up for a wall A/C. All three buildings received needed repairs and fresh paint.

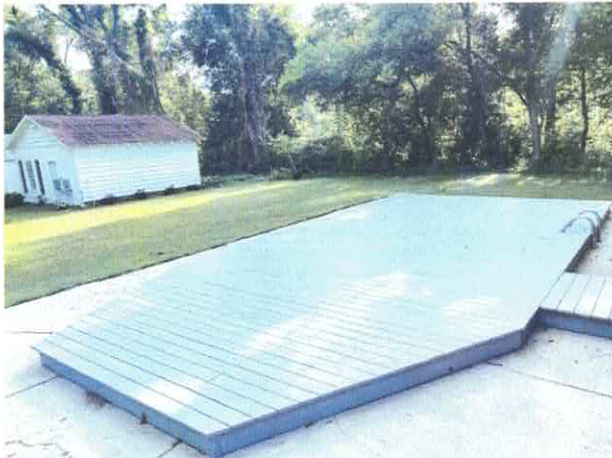
DECKED-OVER POOL: A former owner had installed a 15'x34' in ground pool with concrete deck in the backyard. The pool liner had been removed. Rather than fill it in, the pool was covered

with a heavy wood deck. The deck is sturdy enough to move to one side if a new owner wants to restore the pool. The old pool equipment is still in place, though its condition is unknown.
